**Flood Control Project Maintenance  
Levee Inspections**  
**LMA District Cover Sheet**  
**Spring 2017 Levee Inspection Results**

**Reclamation District No. 0010 Honcut**

**Spring 2017 Levee Inspection Results**

Waterway			Bank	Unit Miles
Unit No. 01 Simmerly Slough			Right	7.65
	Spring (March - May)	Summer (June - August)	(September - November) Fall	Winter (December - February)
Unit Maintenance Rating (Fall Only)				
Date of Inspection	4/11/2017 - 4/11/2017			
DWR Inspector	Sterling York			
Accompanied By	Finlay Williams

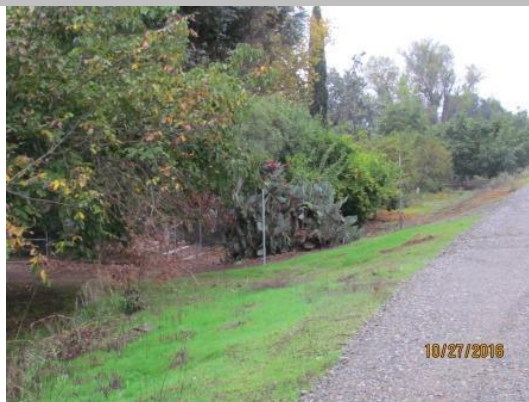
Photo 1 of 1 : SP\_2017\_RD0010\_164\_37\_20170316\_00016.jpg

LM Start	10.94	Rating **	M	Issue No.	37
LM End	10.94	Issue Type +	En	Location *	LS
Category	Earthen Levee			GPS Latitude/Longitude	
				Start	End
Item	Vegetation			39.304087 °	39.304087 °
				-121.618086 °	-121.618086 °
DWR ID	DWR_RD0010_02_f_2015_37				
Comment Code					
V6 : Landscaping					
Inspector Comment					
Landscaping on levee toe should be removed.

View of the cactus on the landward side of the levee looking downstream.

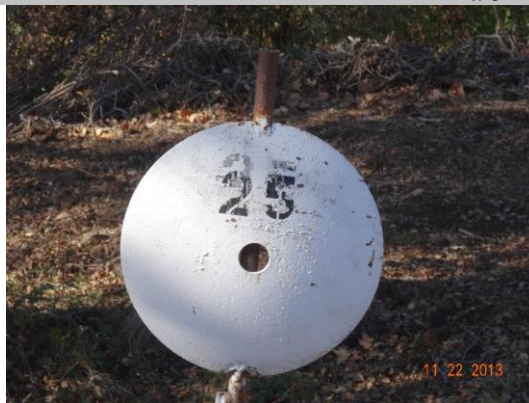
Photo 1 of 3 : UCIP\_SP\_2017\_24840\_44753.jpg

FS\_ID:24840  
 DS\_ID:21305  
 EP\_NO: N/A  
 Repair Type: Non-Urgent  
 Crossing Status: Found  
 UCIP Comments: Burrow activity--large holes found on landward side. Crossing on landward side is blocked. Recommend clearing headwall and crossing. Need to coordinate with owner to determine status of crossing. If crossing is no longer in use owner will need to contact the CVFPB to comply with Title 23. This crossing is referenced in the USACE Periodic Inspection as item USACE\_CESPK\_HON2\_2013\_p\_0476.  
 FIELD\_STRUCT\_DESC: 24-inch CM pipe through the levee, 7.5 feet below the crown. Two CM cutoff walls around pipe at both shoulders. Flap gate on the waterward end. Concrete headwall at both toes. Saddle and apron on waterward side. (USACE-1953). This entry matches the Drainage or Irrigation Structure referenced in O&M manual (Station 674+73).  
 FS Date: 4/30/2013

Marker visible on waterward side, crossing is referenced as No. 25.

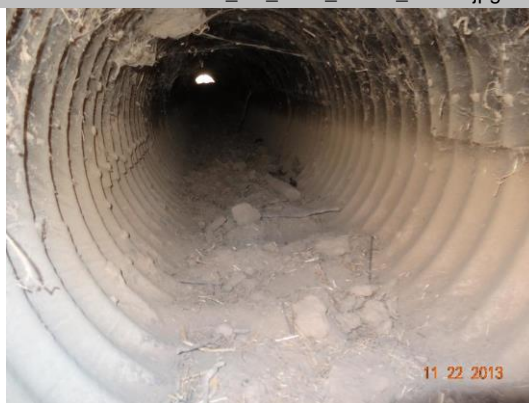
Photo 3 of 3 : UCIP\_SP\_2017\_24840\_44751.jpg

Internal view of pipe wall from waterward side.

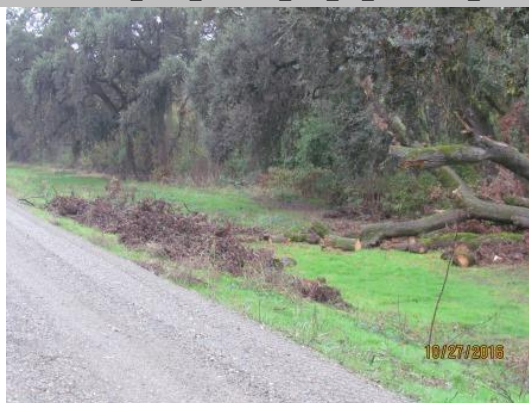
Photo 1 of 1 : SP\_2017\_RD0010\_164\_52\_20170316\_00022.jpg

LM Start	11.15	Rating **	M	Issue No.	52
LM End	11.15	Issue Type +	Ma	Location *	WS
Category	Earthen Levee			GPS Latitude/Longitude	
				Start	End
Item	Trim / Thin Trees			39.307133 °	39.307133 °
				-121.617263 °	-121.617263 °
DWR ID	DWR_RD0010_02_f_2016_52				
Comment Code					
T2 : Thin trees to allow visibility of the ground and room to flood fight.					
Inspector Comment					
Tree fell this fall and the limbs need to be removed from levee slope. Fall 2016.

View of waterside looking downstream where a tree fell this fall and the limbs need to be removed from levee slope. Fall 2016.

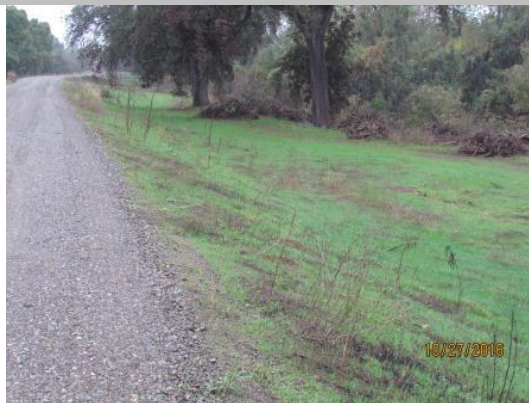
Photo 1 of 1 : SP\_2017\_RD0010\_164\_78\_20170316\_00041.jpg

LM Start	11.28	Rating **	M	Issue No.	78
LM End	11.28	Issue Type +	Ma	Location *	LS
Category	Earthen Levee			GPS Latitude/Longitude	
				Start	End
Item	Animal Control			39.308973 °	39.308973 °
				-121.616803 °	-121.616803 °
DWR ID	DWR_RD0010_02_s_2016_78				
Comment Code					
A1 : Exterminate rodents and backfill and compact or grout burrows.					
Inspector Comment					
No squirrel activity and holes have been backfilled. Spring 2017

View of the waterside looking downstream where the rodent hole have been backfilled. Fall 2016.

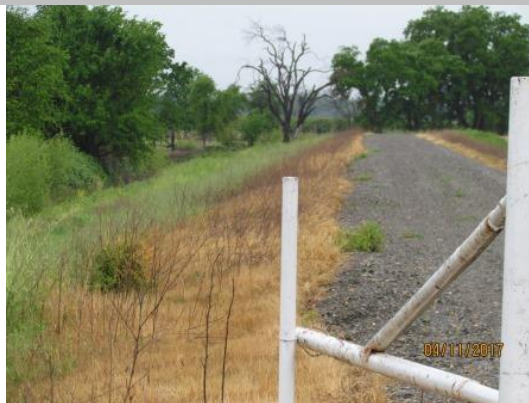
Photo 1 of 1 : SP\_2017\_RD0010\_165\_4\_20170414\_00012.jpg

LM Start	0.01	Rating **	M	Issue No.	4
LM End	2.80	Issue Type +	Ma	Location *	LS
Category	Earthen Levee			GPS Latitude/Longitude	
				Start	End
Item	Vegetation			39.310071 °	39.298542 °
				-121.616274 °	-121.569999 °
DWR ID	DWR_RD0010_03_s_2017_4				
Comment Code					
V1 : Control annual grass and weeds on the levee slopes and easements.					
Inspector Comment					
Annual vegetation needs to be Maintained the crown and shoulders have been sprayed, Spring 2017.

View looking downstream of annual vegetation. The slope needs to be maintained, the crown and shoulders have been sprayed, Spring 2017.

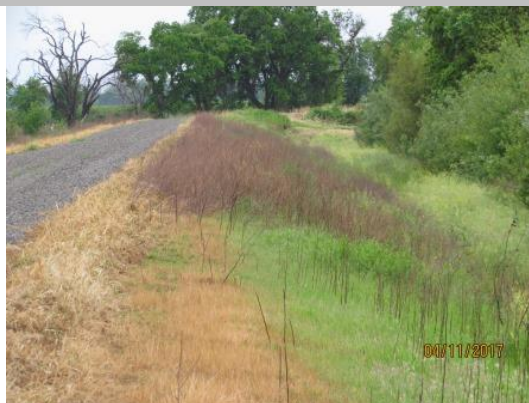
Photo 1 of 1 : SP\_2017\_RD0010\_165\_5\_20170414\_00013.jpg

LM Start	0.01	Rating **	M	Issue No.	5
LM End	2.80	Issue Type +	Ma	Location *	WS
Category	Earthen Levee			GPS Latitude/Longitude	
				Start	End
Item	Vegetation			39.310073 °	39.298542 °
				-121.616272 °	-121.570000 °
DWR ID	DWR_RD0010_03_s_2017_5				
Comment Code					
V1 : Control annual grass and weeds on the levee slopes and easements.					
Inspector Comment					
Annual vegetation needs to be Maintained the crown and shoulders have been sprayed, Spring 2017.

View looking downstream of annual vegetation. The slope needs to be maintained, the crown and shoulders have been sprayed, Spring 2017.

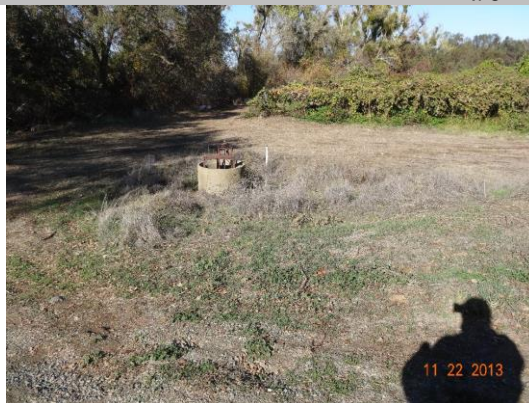
Photo 1 of 3 : UCIP\_SP\_2017\_24841\_44759.jpg

FS\_ID:24841  
DS\_ID:21306  
EP\_NO: N/A  
Repair Type: Non-Urgent  
Crossing Status: Found  
UCIP Comments: Debris found inside crossing--recommend removing it.  
FIELD\_STRUCT\_DESC: 24-inch CM pipe through the levee, 6.0 feet below the crown. Slide gate in concrete standpipe on the waterward end.  
FS Date: 5/1/2013

View of waterward side.

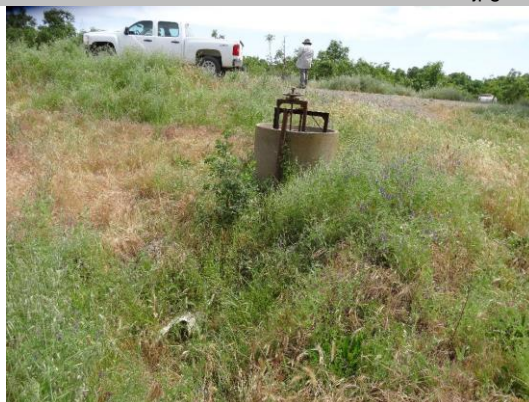
Photo 2 of 3 : UCIP\_SP\_2017\_24841\_44757.jpg

View of concrete standpipe and plastic pipe extension visible on waterward side.

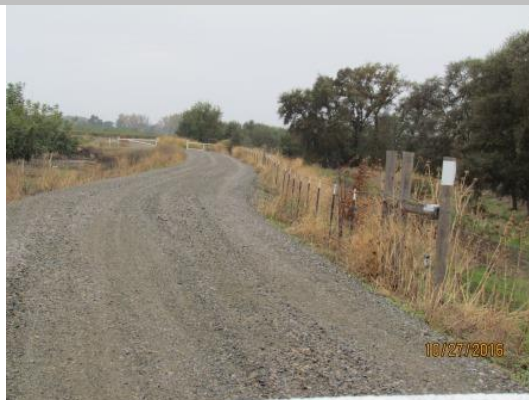
Photo 1 of 1 : SP\_2017\_RD0010\_165\_8\_20170316\_00003.jpg

LM Start	1.08	Rating **	M	Issue No.	8
LM End	1.21	Issue Type +	En	Location *	WS
Category	Earthen Levee			GPS Latitude/Longitude	
				Start	End
Item	Encroachments			39.307106 °	39.306422 °
				-121.597439 °	-121.595205 °
DWR ID	DWR_RD0010_03_s_2016_8				
Comment Code					
FE : Fence					
Inspector Comment					
Unpermitted fence on waterside levee hinge point.

View of an unpermitted fence on waterside levee hinge point.

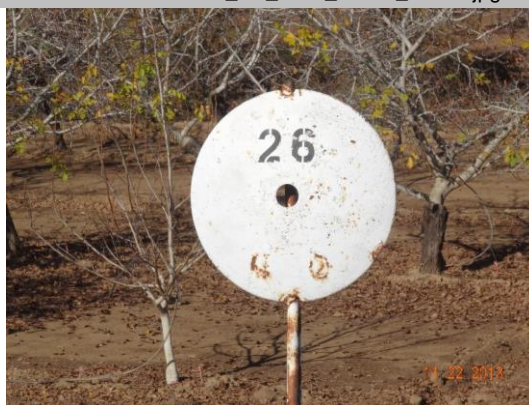
Photo 1 of 3 : UCIP\_SP\_2017\_24842\_44764.jpg

Comment Code					
Inspector Comment					
FS_ID:24842					
DS_ID:21307					
EP_NO: N/A					
Repair Type: Non-Urgent					
Crossing Status: Found					
UCIP Comments: Sediment deposit inside pipe--Need to coordinate with owner to determine status of crossing. If crossing is no longer in use owner will need to contact the CVFPB to comply with Title 23.					
FIELD_STRUCT_DESC: 24-inch CM drainpipe through the levee, 15.0 feet below the crown. Two CM cutoff walls around pipe at both shoulders. Flap gate on the waterward end. Slide gate on the landward end. Concrete headwall at both toes. (USACE-1953). This entry matches the Drainage or Irrigation Structure referenced in O&M manual (Station 134+06).					
FS Date: 5/1/2013

Marker visible on waterward side--No. 26.

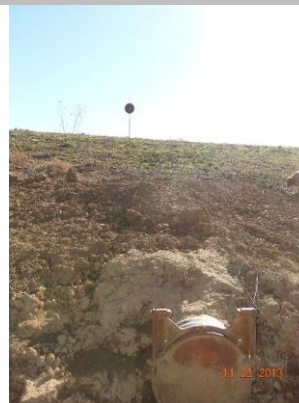
Photo 2 of 3 : UCIP\_SP\_2017\_24842\_44762.jpg

View of waterward slope.

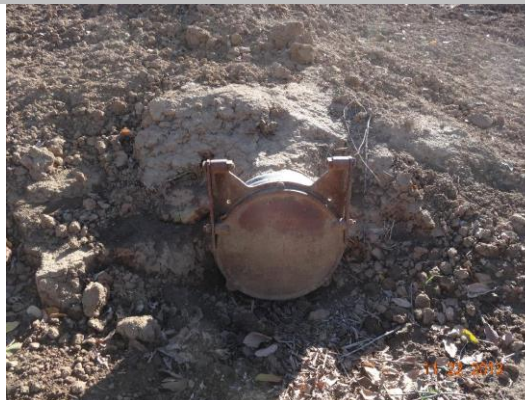
Photo 3 of 3 : UCIP\_SP\_2017\_24842\_44763.jpg

View of flap gate located on waterward side.

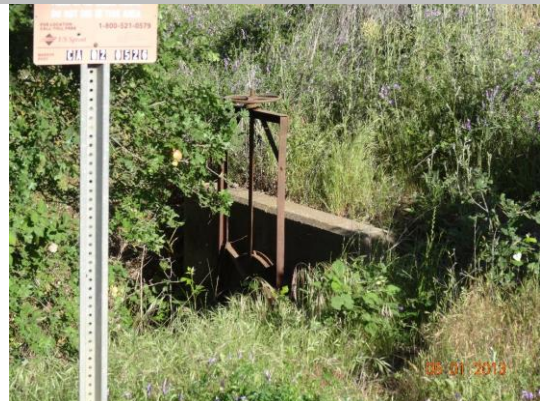
Photo 1 of 2 : UCIP\_SP\_2017\_24883\_44820.jpg

Comment Code					
Inspector Comment					
FS_ID:24883 DS_ID:21308 EP_NO: N/A Repair Type: Non-Urgent Crossing Status: Found UCIP Comments: Dense vegetation limits the inspector's visibility to identify signs of pipe failure (leaks) along the slope. Recommend removing vegetation along pipe alignment to conduct proper inspection of structure and appurtances. FIELD_STRUCT_DESC: 24-inch pipe through the levee, 12.0 feet below the crown. Two CM cutoff walls around pipe at both shoulders. Flap gate on the waterward end. Slide gate on the landward end. Concrete headwall at the landward toe. (USACE-1953). This entry matches the Drainage or Irrigation Structure referenced in O&M manual (Station 192+33). FS Date: 5/1/2013

View of slide gate and concrete headwall located on landward side.
